# NAVAL POSTGRADUATE SCHOOL

COMBAT DAMAGE ASSESSMENT TEAM  
A-10/GAU-8 LOW ANGLE FIRINGS  
VERSUS  
SIMULATED SOVIET TANK COMPANY  
(15 June 1978)

August 1979

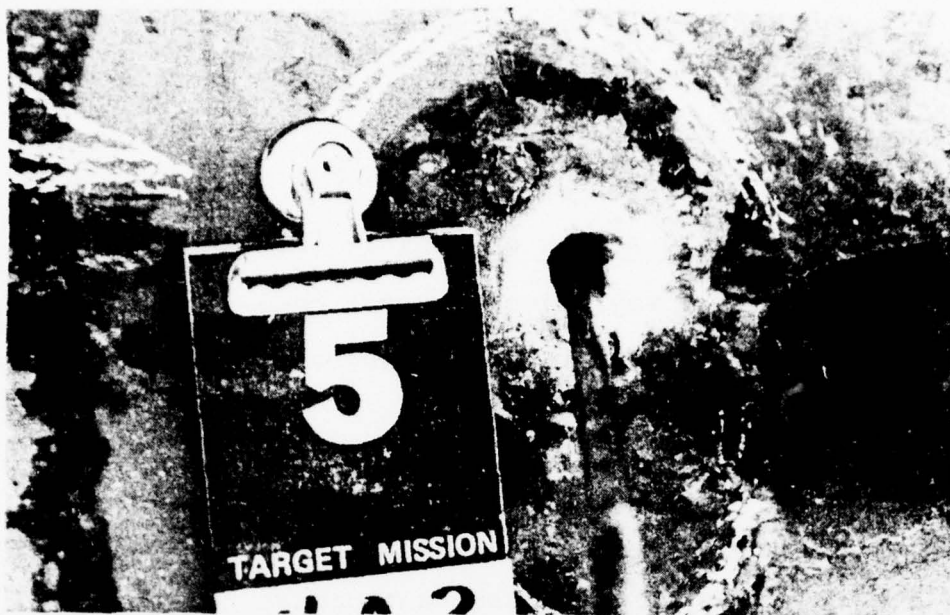
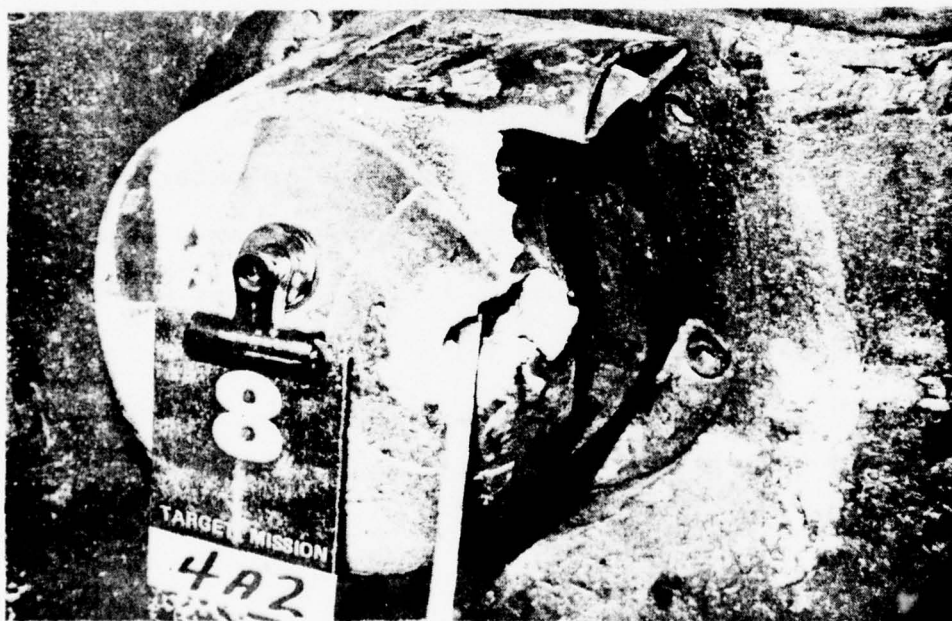
- b. F-70%: based on wounded L (Impact 5), damaged range-finder (Impact 8), and perforated gun tube (Impact 12) (See Figs. 17, 18, and 19).

Figure 17. -- TARGET 4, IMPACT 5

Figure 18. -- TARGET 4, IMPACT 8

Figure 19. -- TARGET 4, IMPACT 12

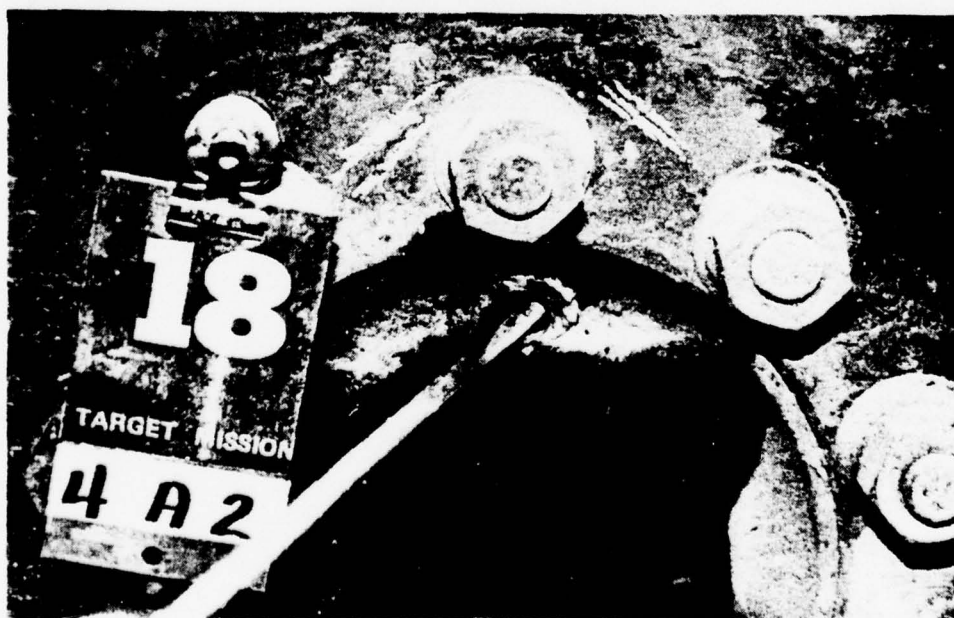
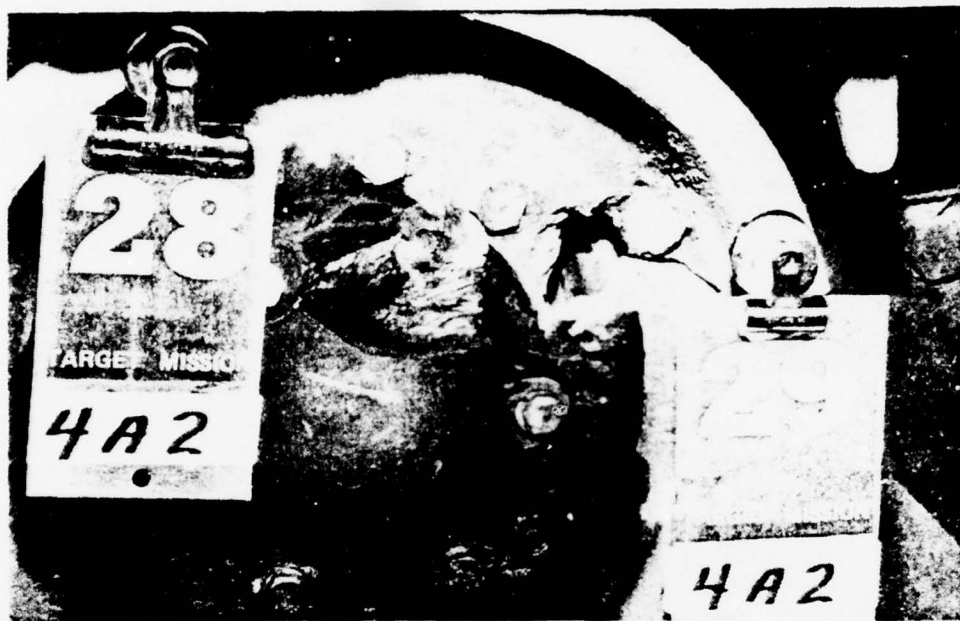
3. Rationale for Kill Assessment:
  - a. M-70%: based on cumulative damage to exterior mobility components especially the penetrated right number 5 road wheel hub (Impact 18) and cracked number 1 track support wheel hub (Impact 28). (See Figs. 20 and 21).

Figure 20. -- TARGET 4, IMPACT 18

Figure 21. -- TARGET 4, IMPACTS 28 AND 29

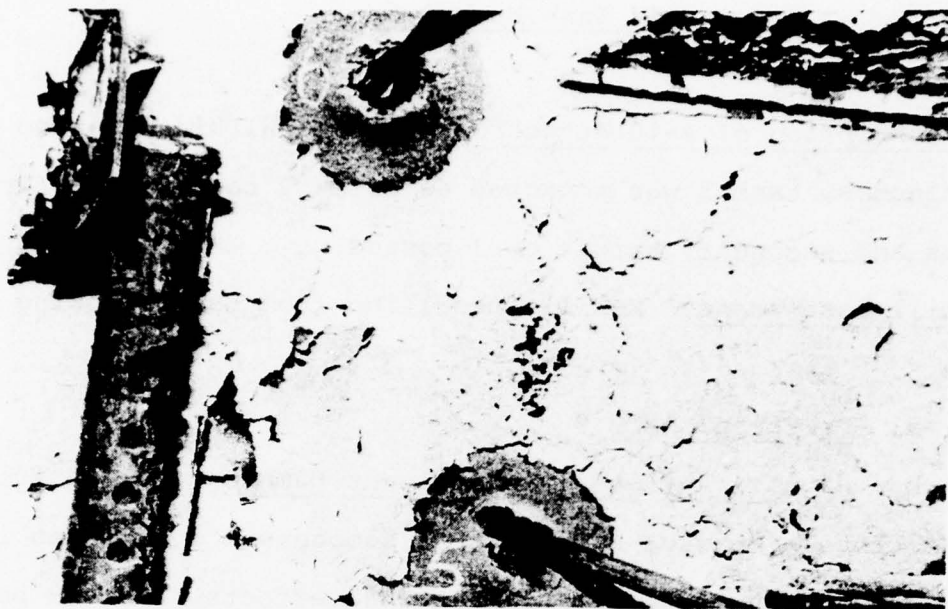
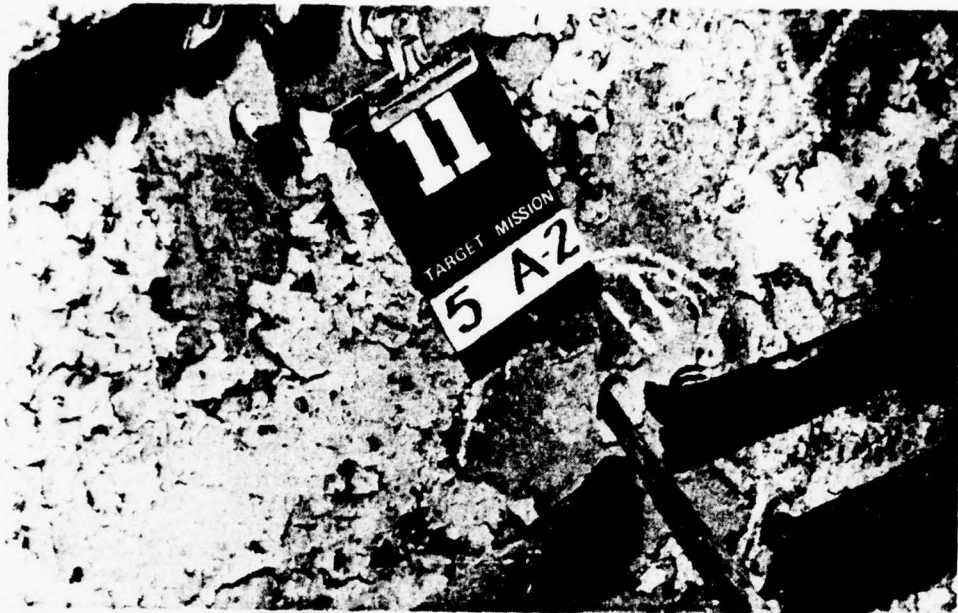
3. Rationale for Kill Assessment: Every one of the 4 perforations into the turret and 5 perforations into the hull could have ignited either fuel or ammunition. By 10.3 minutes from the time it was first fired on, tank 5 was observed burning. Several minutes earlier the tank was observed smoking and the CDAT concludes that a fuel (or oil) fire was ignited and rapidly developed into catastrophic explosions of stowed ammunition and ignition of fuel in main cells. The crew casualties assessed from perforations 5, 6, 8, and 11 would have prevented the crew from controlling any internal fire. (See Figures 22, 23, 24 and 25.)

Figure 22 . -- TARGET 5, INTERIOR VIEW OF IMPACTS 5 AND 6

Figure 23 . -- TARGET 5, IMPACT 8

Figure 24. -- TARGET 5, IMPACT 11

Figure 25. -- TARGET 5, INTERIOR VIEW OF IMPACT 11

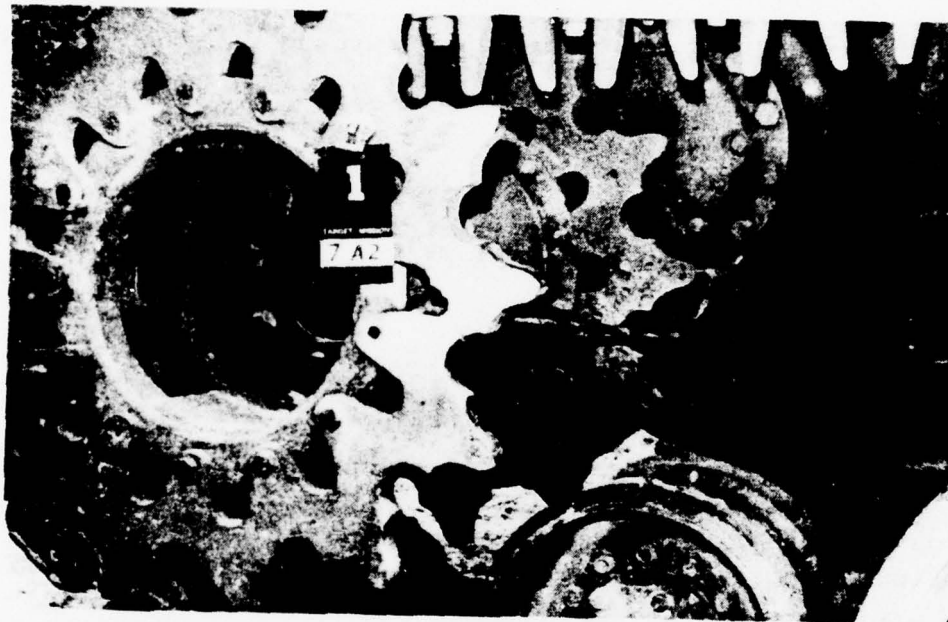
Figure 29 . -- TARGET 7, IMPACT 1

3. Rationale for Kill Assessment: One perforation was achieved into the transmission compartment (impact 1, see Fig. 29).

Although the transmission was not damaged, the impact damaged the right drive sprocket. Six additional hits (non-perforating impacts) were scored (impacts 3, 5, 6, 9, 10, and 11), which significantly damaged the track, road wheels, and track support rollers of the target tank. The partial mobility kill was assessed on the basis of the cumulative damage resulting from impact 1 and also especially impacts 9 and 10 (see Figs. 30 and 31).

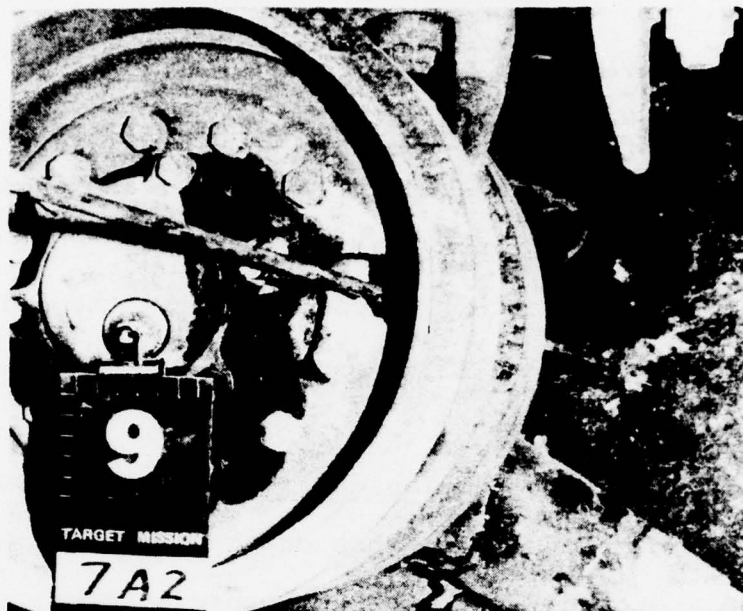
Figure 30. -- TARGET 7, IMPACT 9

Figure 31. -- TARGET 7, IMPACT 10

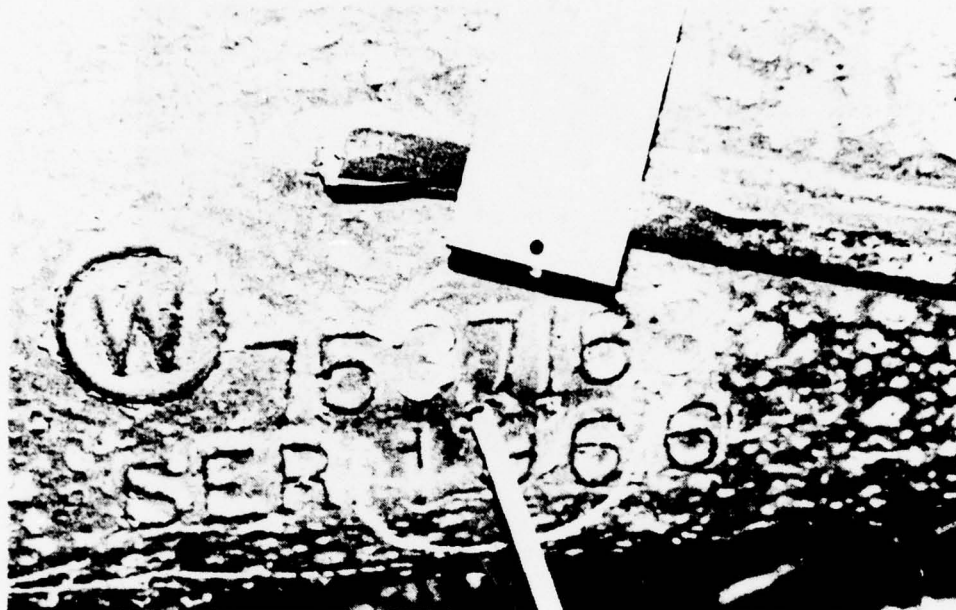
3. Rationale for Kill Assessment: Three perforations (3, 4, and 27; see Figs. 32, 33, and 38 ) were achieved into the fighting compartment, two of which had the capability of causing crew casualties and/or igniting stowed ammunition. Four perforations (12, 13, 18, and 23; see Figs. 34, 35, 36, and 37 ) were achieved into the engine compartment, one of which penetrated into the right fuel tank. The CDAT assessed an immediate K-Kill resulting largely from perforation 23 through the right fuel tank, which in combination with the casualty-producing perforations (impacts 3 and 4), other perforations, and external impacts resulted in an uncontrollable fuel fire.

Figure 32. -- TARGET 11, IMPACT 3

Figure 33. -- TARGET 11, INTERIOR VIEW OF IMPACT 4

Figure 38. -- TARGET 11, IMPACT 27

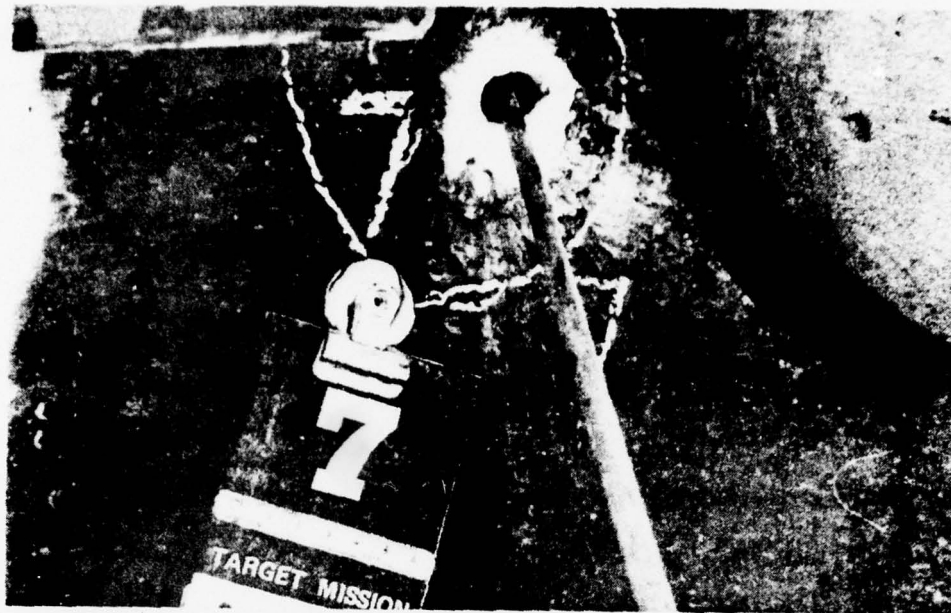
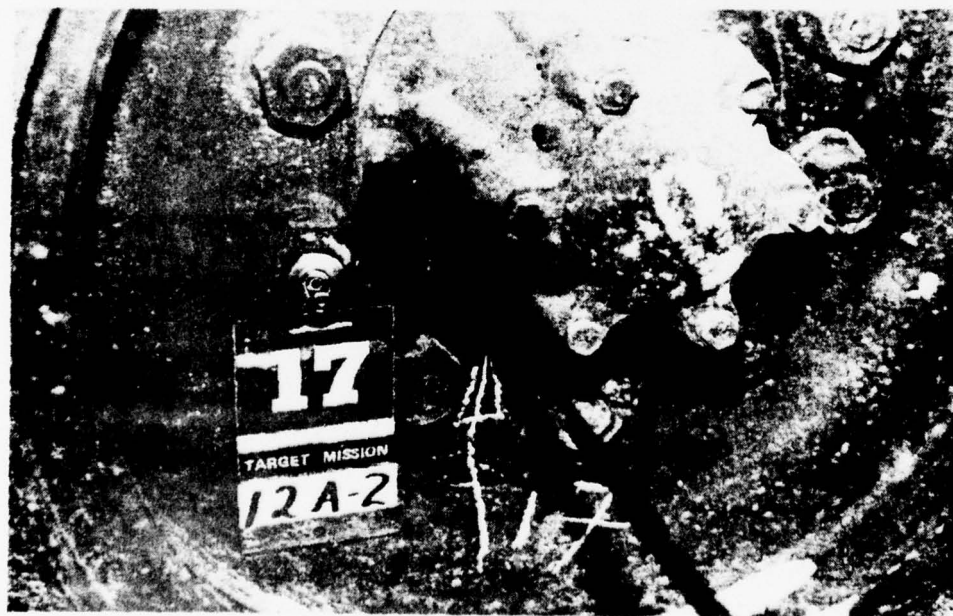
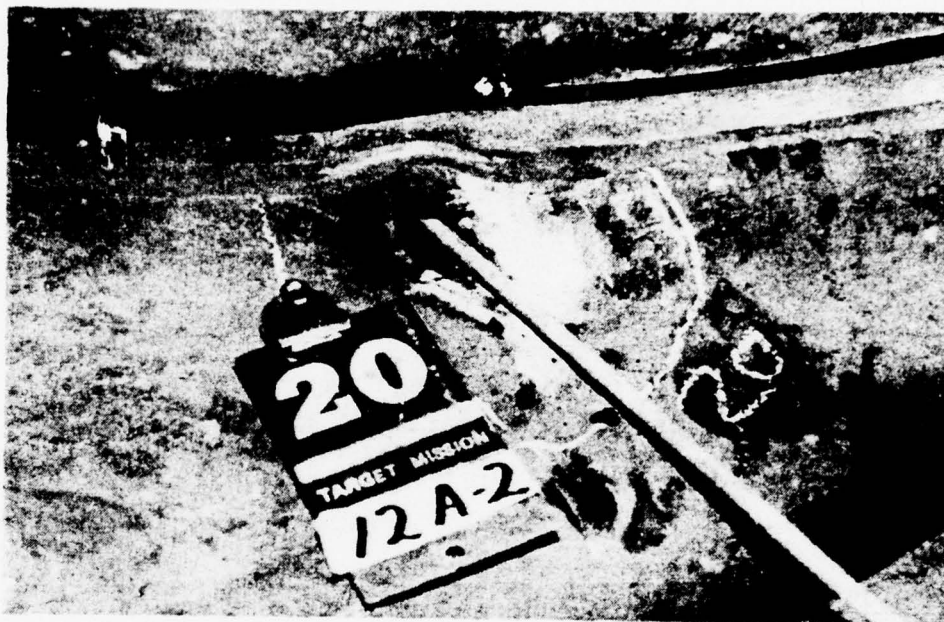
b. F-100%: based on perforations 5, 6, 7, and 27, which killed or wounded all five crew members, and impacts 20 and 23, which jammed the turret making it impossible to traverse.

c. See Figs. 39, 40 and 41 for photographs illustrating the weapon effects and damage from impacts 7 (gunner casualty), 17 (road wheel hub penetrated), and 20 (turret jammed).

Figure 39. -- TARGET 12, IMPACT 7

Figure 40. -- TARGET 12, IMPACT 17

Figure 41 . -- TARGET 12, IMPACT 20

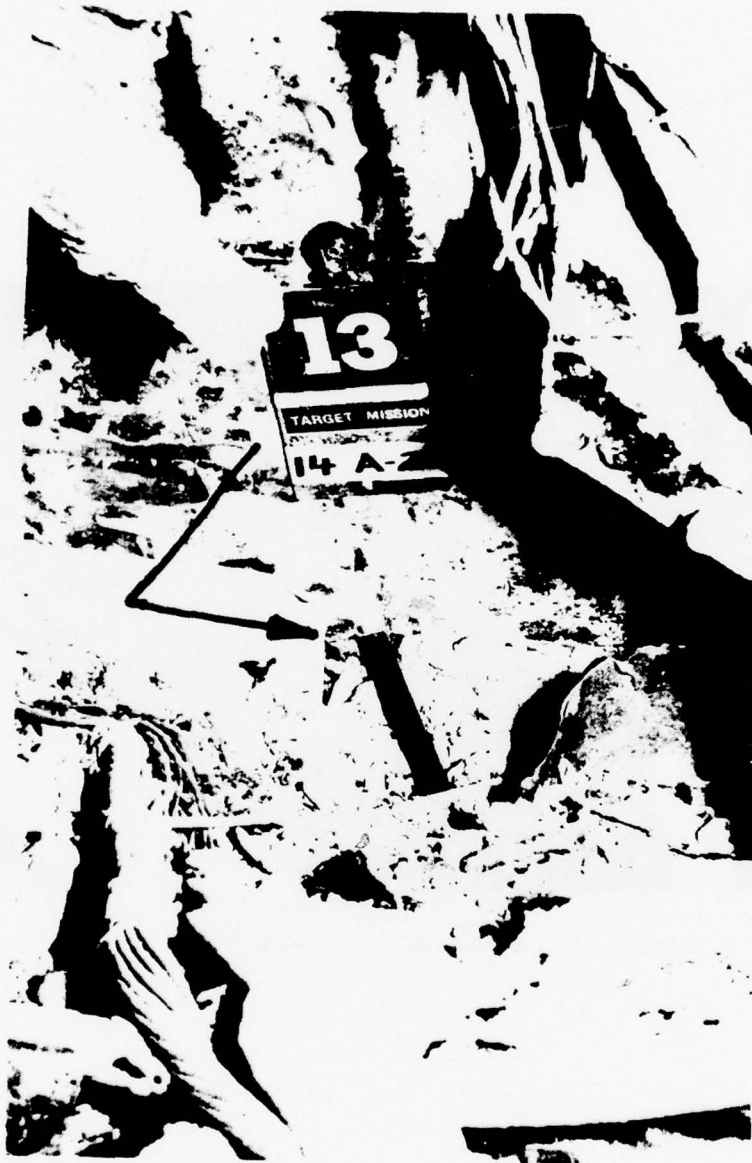
3. Rationale for Kill Assessment: The CDAT assessed the damage to tank 14 as an immediate catastrophic kill based on the observed internal ammunition explosion during the first firing pass against it. Perforation number 13, which had the location, azimuth, and residual energy to contact and (ignite) stowed ammunition was the killing agent (see Figs. 42, 43).

Figure 42. -- TARGET 14, IMPACT 13

Figure 43. -- TARGET 14, INTERIOR VIEW OF IMPACT 13
